# Truncation Artifact Presenting as Cropped Projections and Wedge Defect in Sinogram During Single-Photon Emission Computed Tomography

✉ Mohsen Qutbi<sup>1</sup>, ✉ Reyhane Ahmadi<sup>2</sup>, ✉ Amirmohammad Alinejad<sup>1</sup>

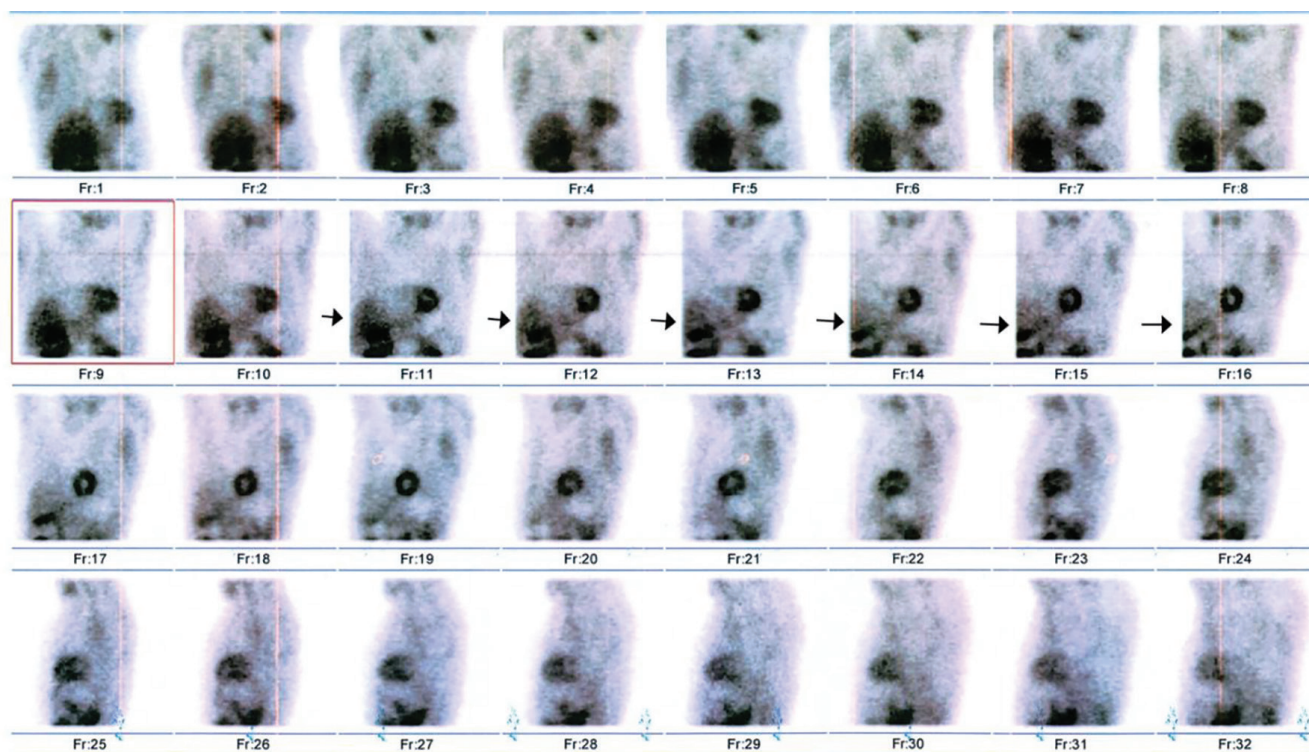
**Figure 1.** A 50-year-old man presented for myocardial perfusion single-photon emission computed tomography imaging. Scans are conducted during the stress and rest phases using a dual-headed gamma camera (Siemens Symbia T series) configured at a  $90^\circ$  angle. For resolving the diaphragmatic attenuation effect, prone imaging is performed. On prone imaging, left margin of projections 9 to 16 in the cinematic raw images, which include 32 projections in total and 16 projections for each detector, seems to be cropped incrementally in width.

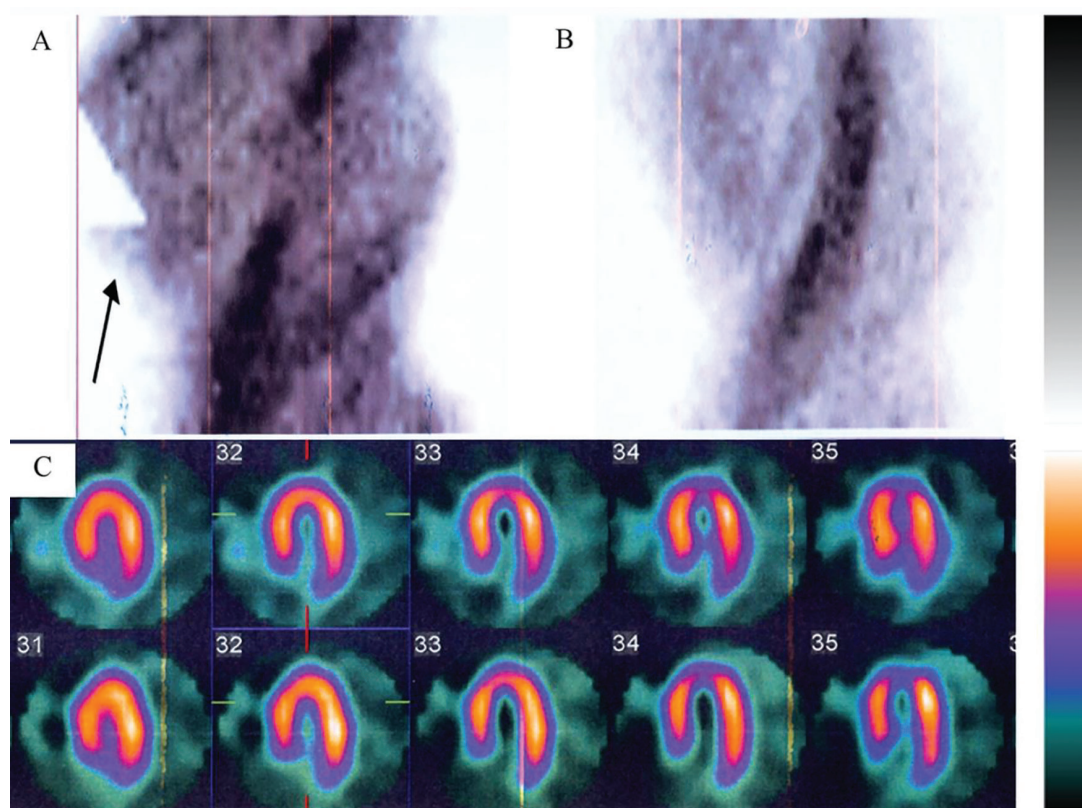
**Figure 2.** Inspecting the related sinograms, a wedge-shaped or triangular zone of absent activity was observed in the left margin of the sinogram of prone stress phase, (as shown by arrow in A) affecting several successive projections. The width of the defect is gradually increasing projection-by-projection until the end of the acquisition arc of detector 1, and, thereafter, abrupt resumption is seen at the beginning of the acquisition arc of detector 2. The tip of the triangular defect does not reach the sinusoidal band of left ventricle (LV) in the sinogram. Fortunately, the liver was resected, and LV remained unaffected. The sinogram of the rest phase is intact, (B). The tomographic slices (C) reconstructed from the horizontal long-axis of the prone and rest phases, using the iterative maximum likelihood expectation maximization method, from this projection dataset were free from this artifact. In rest and stress images performed in the supine position, no similar defect was observed in the sinogram and corresponding tomographic slices. The same finding was observed in other patients' scans, mostly was acquired in prone position, and rarely in supine position (the latter in heavy patients). All routine quality control tests, including the center of rotation test, were acceptable. Truncation artifacts are one of several artifacts affecting single photon emission computed tomography imaging. When the LV is truncated, perfusion defects can occur. In rotating or cinematic images, this problem is easily recognizable, where in some successive projections, LV is abutting the border of projection or being cut. The solution to this problem is easy. When it is noticed, the operator should reposition the axis of rotation of the gantry (detector heads) to the longitudinal or z-axis of the patient. Another source may be encountered when imaging is performed using the option of auto-body contouring. In patients with small body size, some interference occurs between the two detectors because each detector tries to approach the patient. Using bags of saline or covering the patient with folded blankets may rectify this problem; otherwise, another orbit (circular or elliptical) should be applied (1,2,3,4,5). In our case, none of the above sources was the culprit for this artifact. As mentioned, it arises mostly in prone imaging, where the detectors are positioned below the scanning table and disappears when imaging is done in the supine position. In the prone patient position, detectors are rotating around the patient while ascending above the scanning table. One plausible explanation is that because of mechanical instability, the lower positioned detector bears the weight of another detector and thus prevents proper positioning. This is responsible for the graded or incremental truncation of projections, creating a wedge-shaped appearance. The problem remained unresolved after repeated examination by the service engineers accredited by the vendor. This problem can be of interest to engineers and technicians. Fortunately, in this case, the heart was not affected, and the need for repeating or discarding the prone imaging was obviated.
